MATERIALS RESEARCH FOR CLEAN UTILIZATION OF COAL

QUARTERLY PROGRESS REPORT  
October 1 - December 31, 1976  
(JANUARY)  
77

Institute for Materials Research  
National Bureau of Standards  
Washington, D. C. 20234

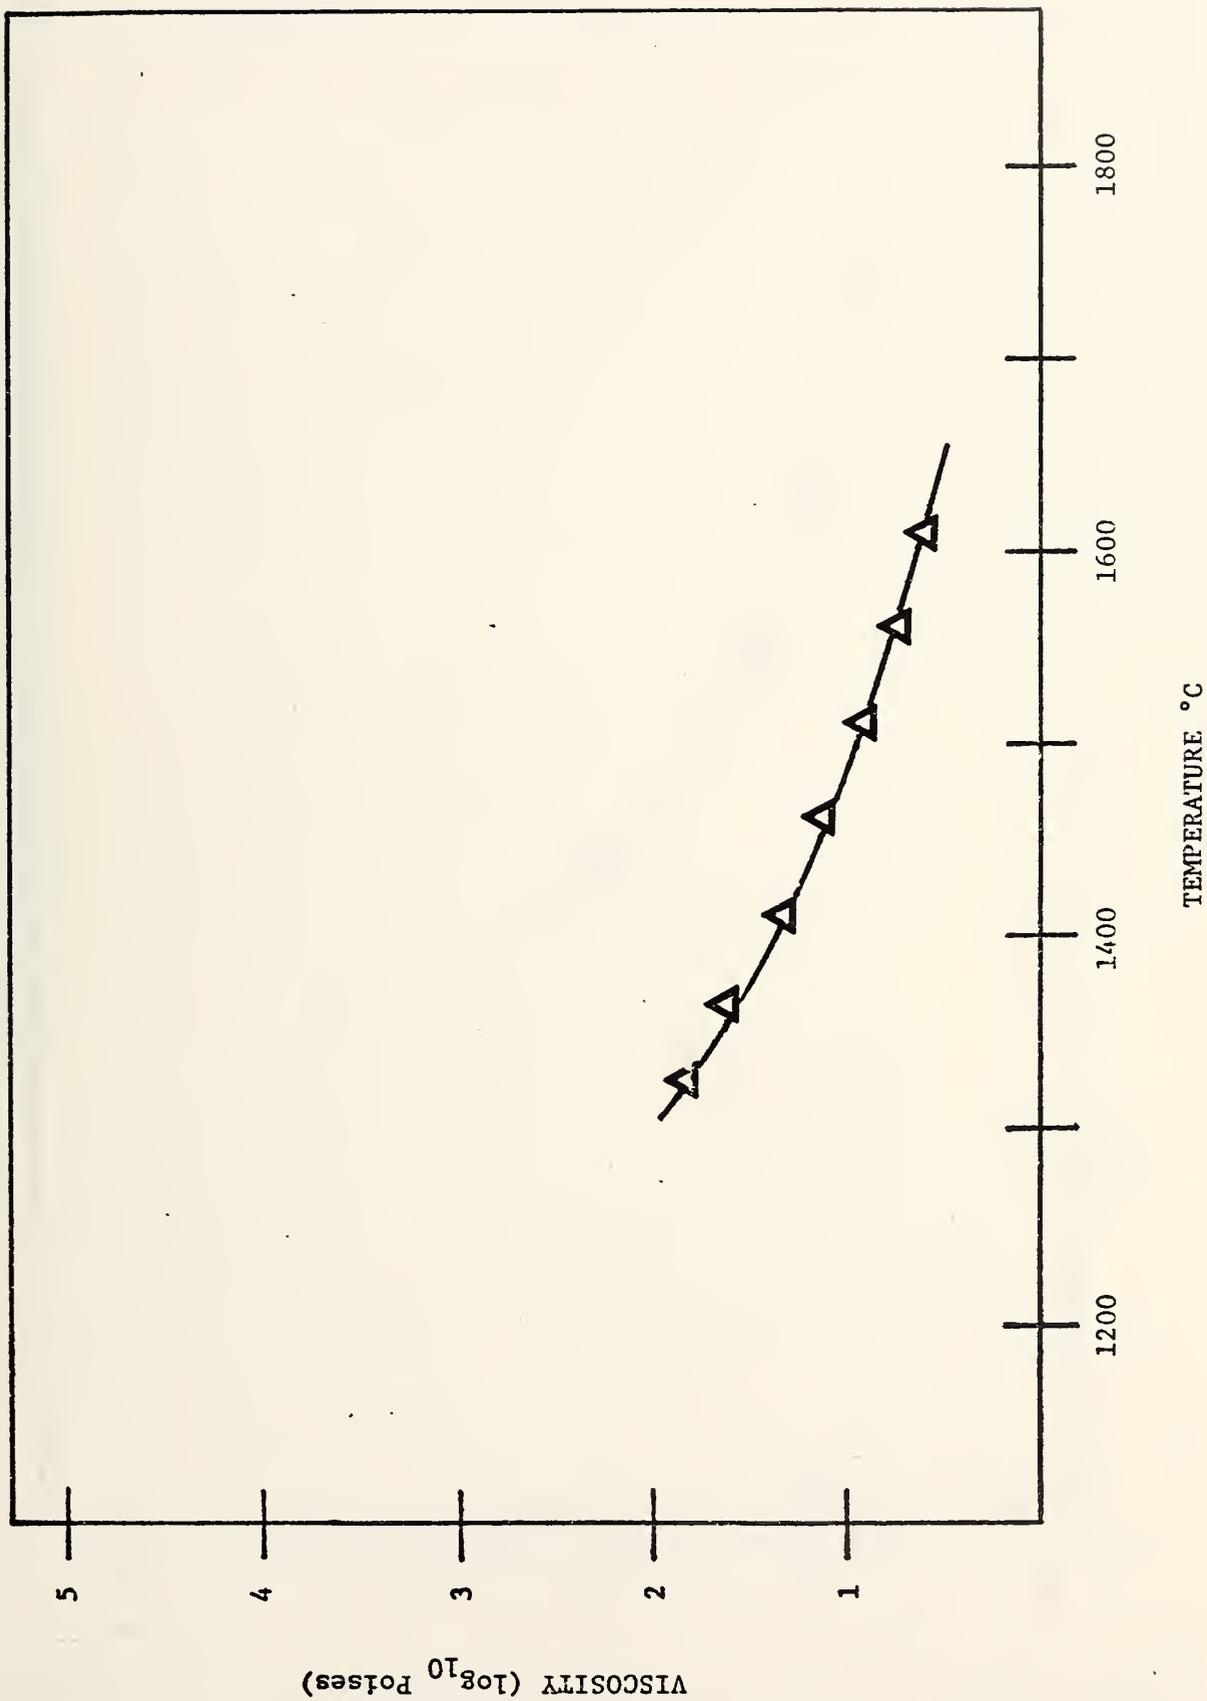
Figure 1a. Viscosity of synthetic slag vs temperature.  
Rosebud Type Coal Ash

Progress: The viscosities of synthetic slags (one modeled after Montana Rosebud Coal Ash analyses and the other modeled after Pittsburgh Seam Coal Ash) have been measured at ambient pressure over the temperature range of 1300°C to 1600°C (Figure 1a and 1b). The compositions are given in Table 1.

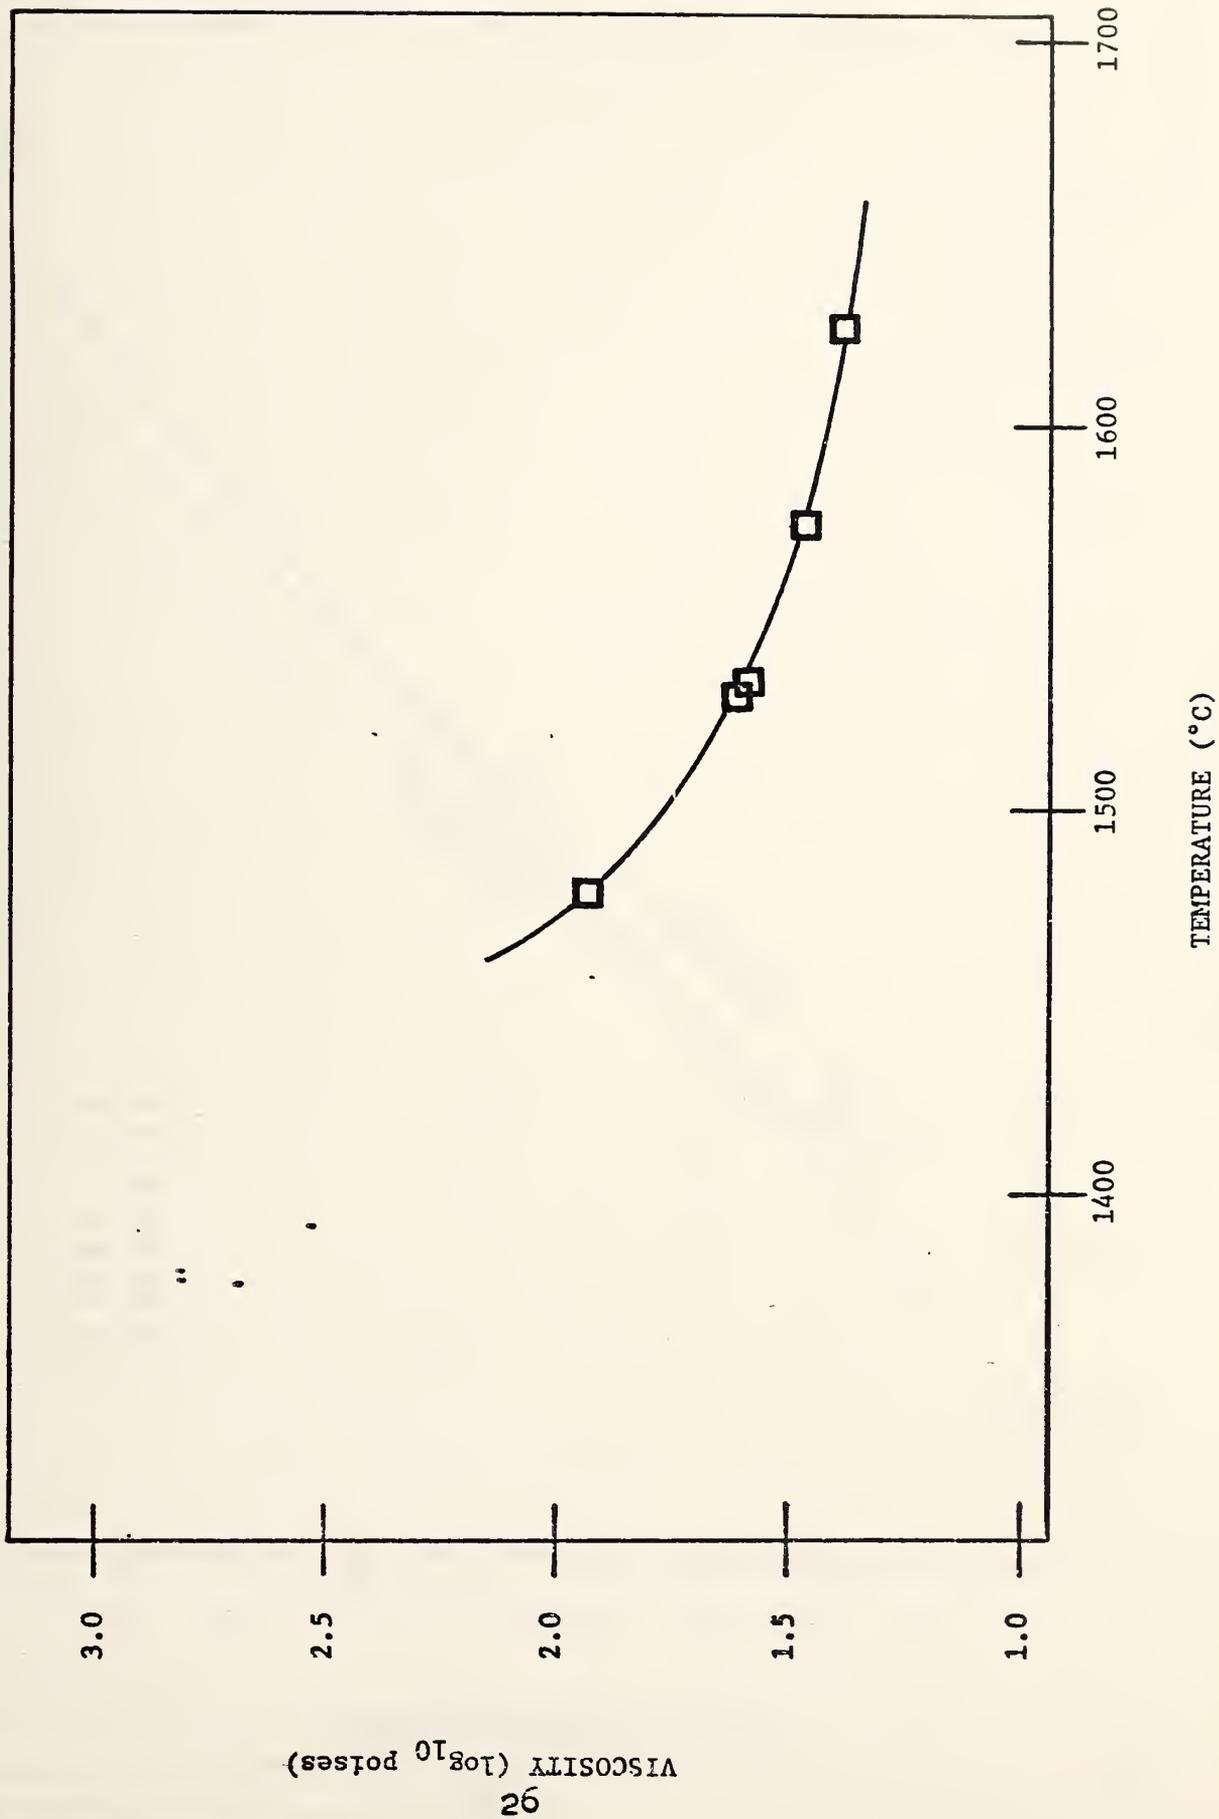
Figure 1b. Viscosity of synthetic slag vs temperature.

Pittsburgh Seam Type Coal Ash

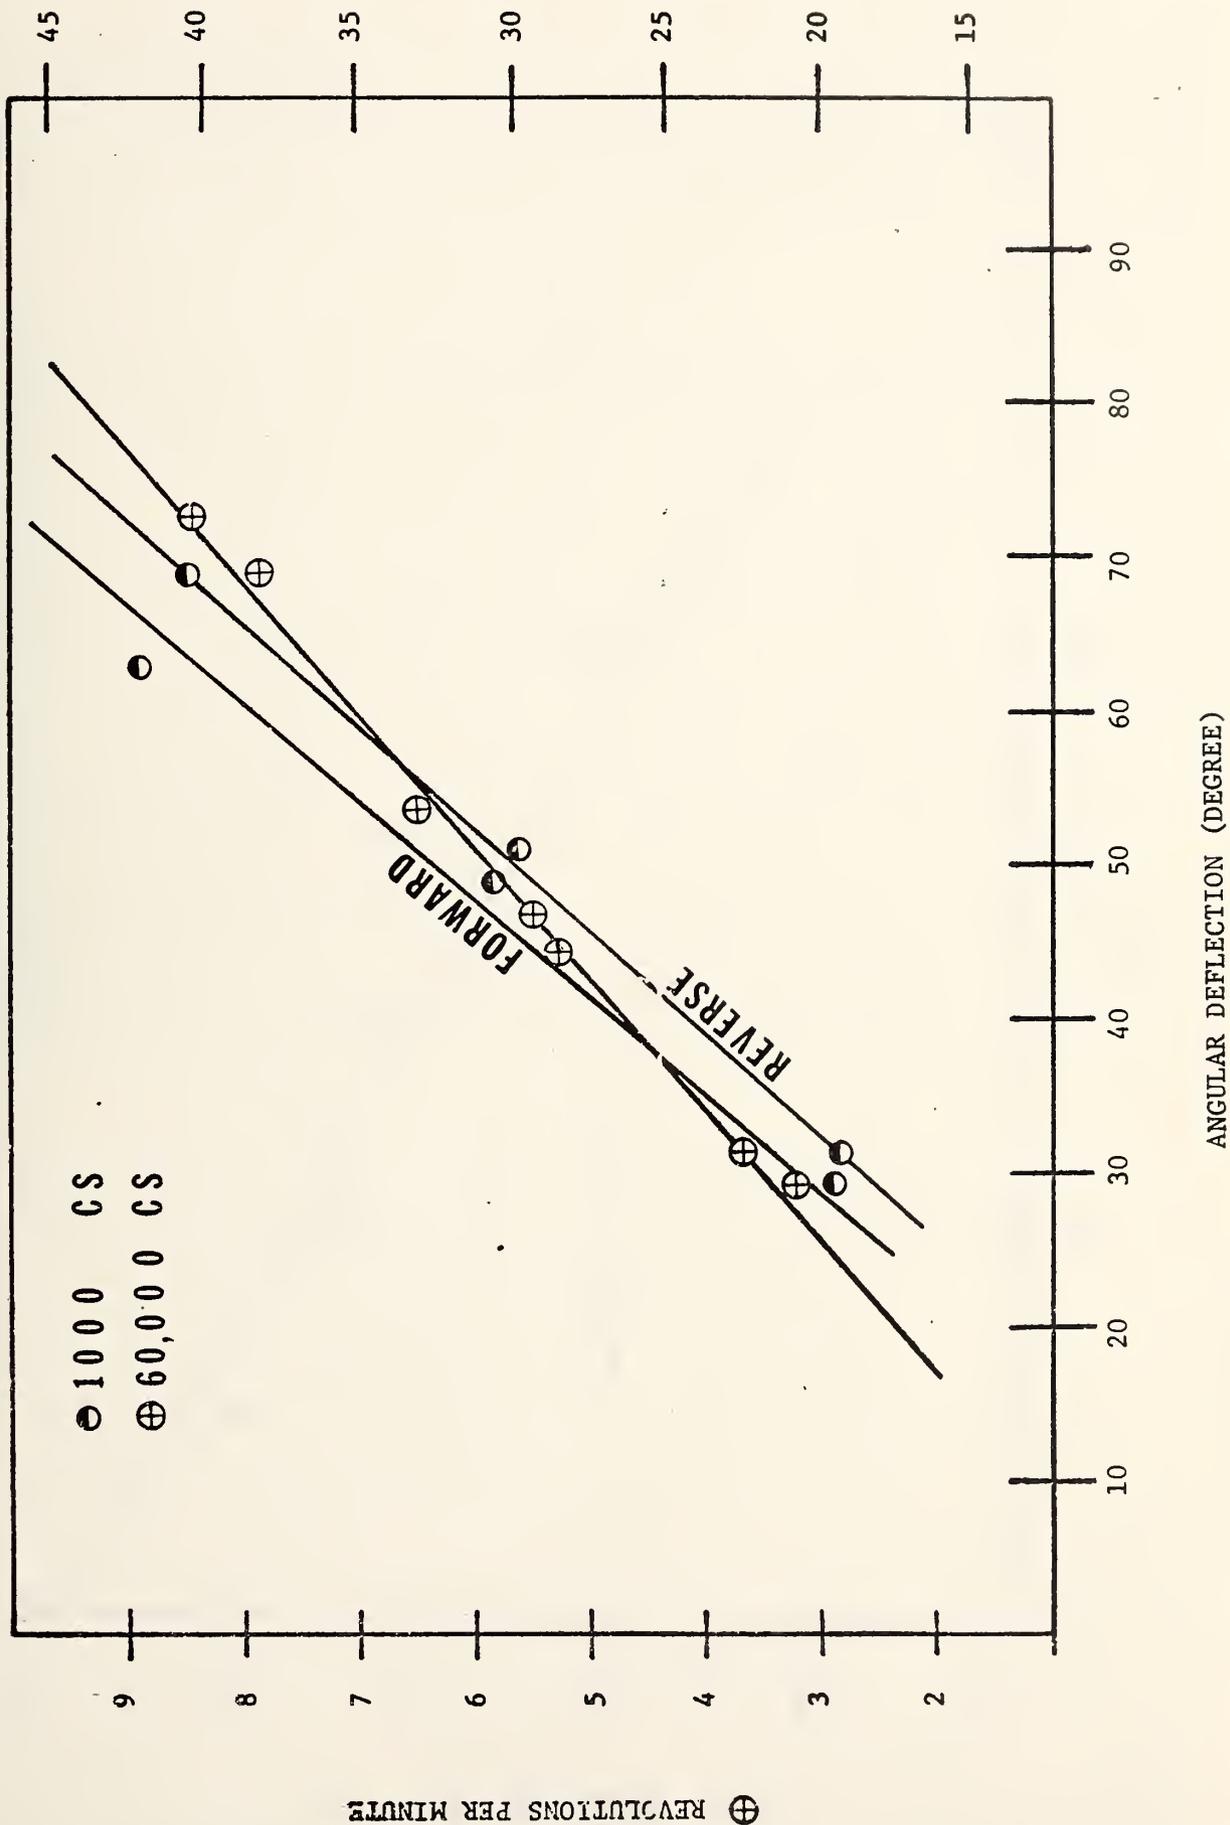
Figure 2. Angular deflection of torsion suspension vs rpm.

The gear motor for crucible rotation has been received and the torsion wire suspensions have been calibrated with two fluids of known viscosity using two different "drag cup geometries" (Figure 2).

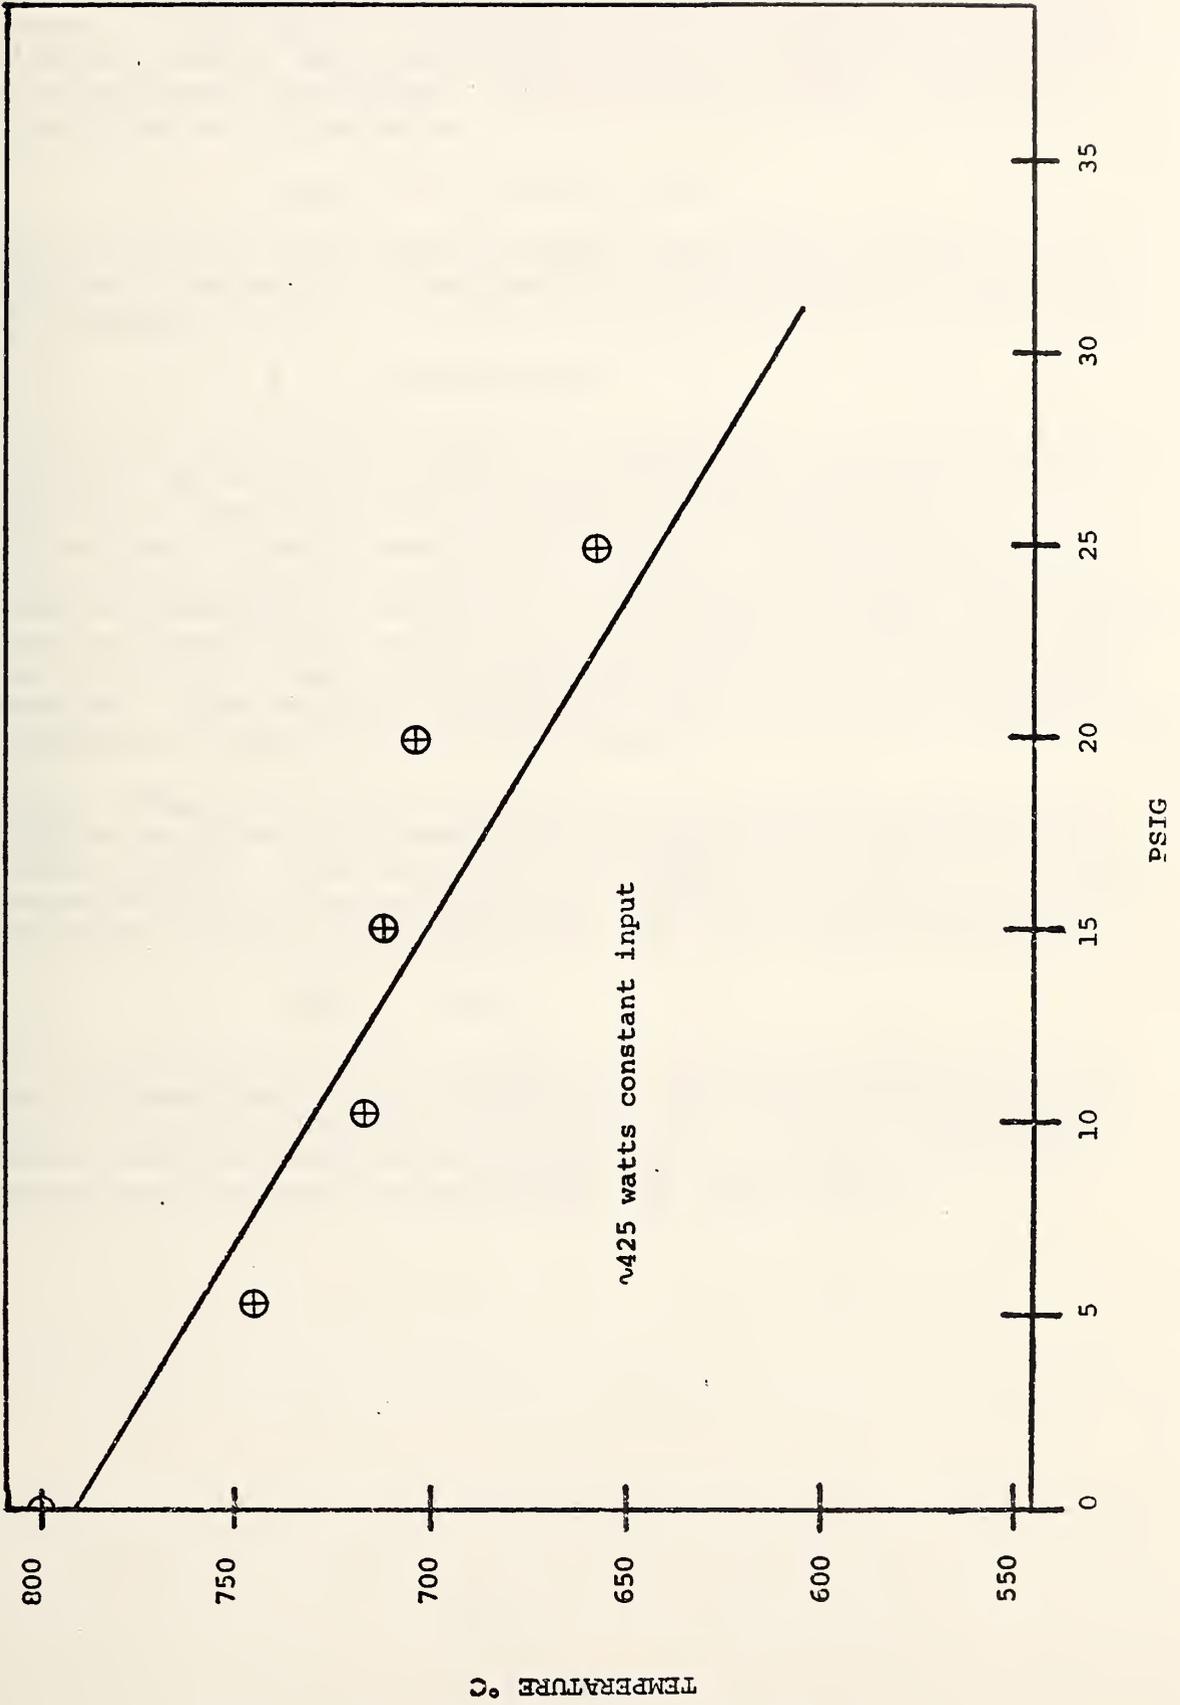
Figure 3. Temperature of strip heater vs pressure.

Preliminary tests have been run in an autoclave operating at 30 psig steam pressure using a platinum strip heater with a radiating area of 15 square inches to evaluate the effect of steam pressure on the heater temperature at a constant power level. A 20% reduction in temperature was observed from ambient pressure to 30 psig (Figure 3) at 800°C.
